## Transport of Dutch breeding cattle to Russia: Observations from 16.02. to 19.02.2007

Date: 16.-19.02.2007

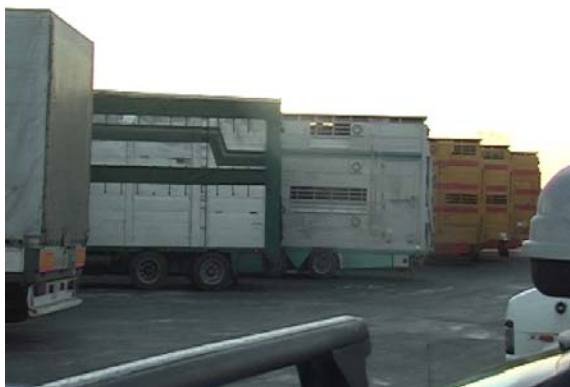
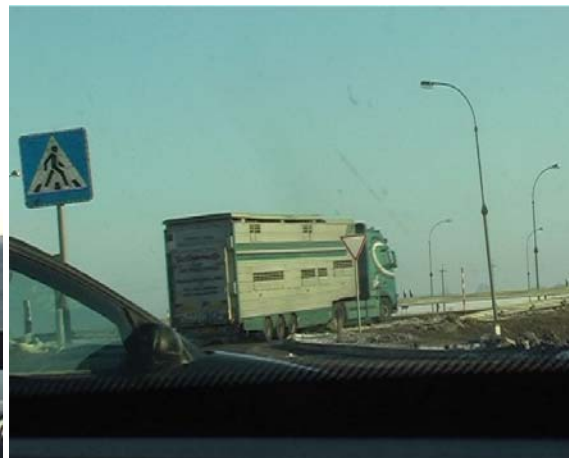
Animals are not fed or given water at any time during that stop.

Trucks loaded with cattle (Hefter and Dijkstra) at gas station in BY, Dijkstra truck leaving gas station at 8:08 CET

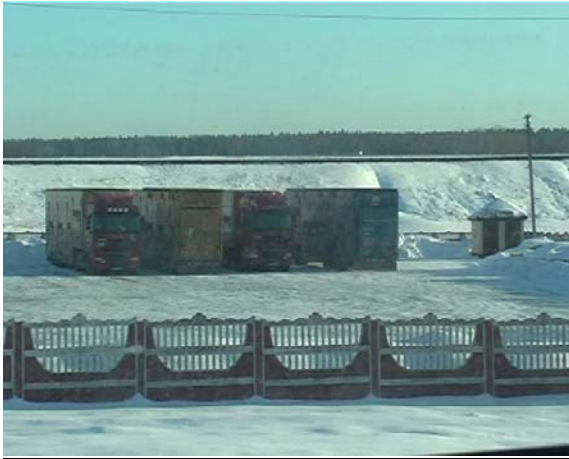
The animals in all 4 trucks are fed with hay, we do not observe that the animals receive water, but we could not observe them at this stop all around the clock.

Hefter trucks parked for 20 hour break at a parking lot: cattle are not unloaded

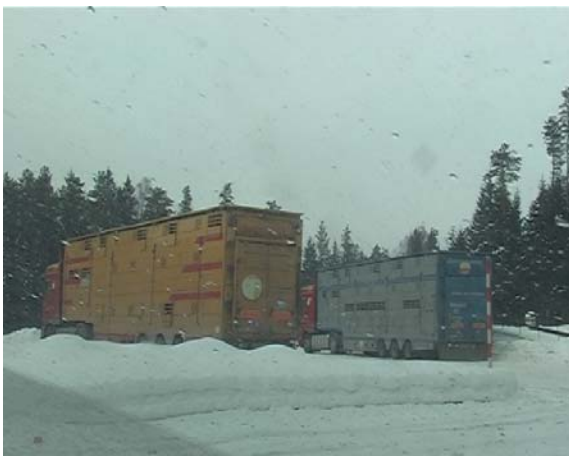
12:00 CET: the trucks with the lic.pl.no. **SU-H-1511** and **SU-H-1671** stop again at a parking lot. The parking lot does not have any possibility to get water.

Again a stop for 1 hour and 40 min at a parking lot

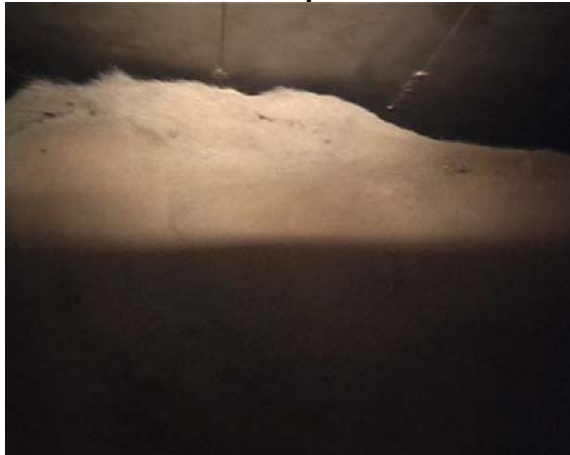
The trucks with the lic.pl.no: **SU-H-1671** enters the customs area right away. The other one with **SU-H-1511** has to wait 10 minutes until it is allowed to enter. We manage to have a look at the animals. One heifer, in the first compartment behind the cab of **SU-H-1511**, is very tall and between her back and the ceiling is not more than a space of 3 cm. Unfortunately we can not get her eartag, because she is facing the side of the truck, where the ventilation bares are closed.

Heifers back almost touching the ceiling
